LEO 2014-01
January 21, 2016

Sergeant Struck by a Motor Vehicle on Interstate Highway— New Mexico

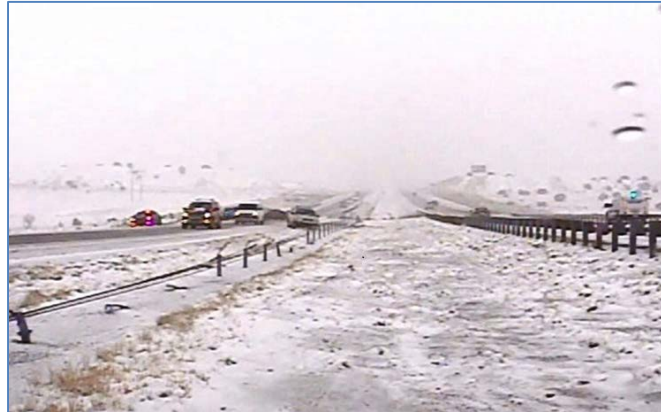
**Looking southbound on the interstate;
conditions immediately prior to a vehicle
striking the sergeant.
(dashcam courtesy of the sheriff department)**

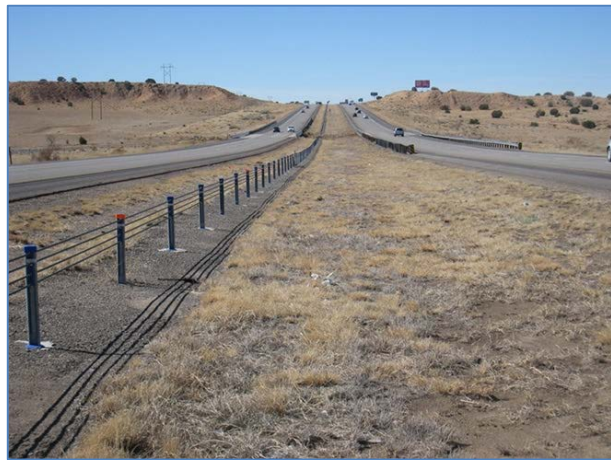
Immediately south of mile marker 254.5, a short bridge spans an arroyo. Guardrails are present along the median side of both directions, extending about 100 yards north of the bridge. The bridge is known to ice over during cold weather conditions.

The highway approaching the crash site in the northbound lanes is a gentle decline approximately 0.5 miles in length, following an incline and crest; the road surface levels out at the bridge and then begins a gentle incline toward the next crest. The speed limit in the area is 70 miles per hour (see Image 1).

Image 1. Incident site looking south; note gentle down-slope to north end of bridge. (NIOSH photograph)

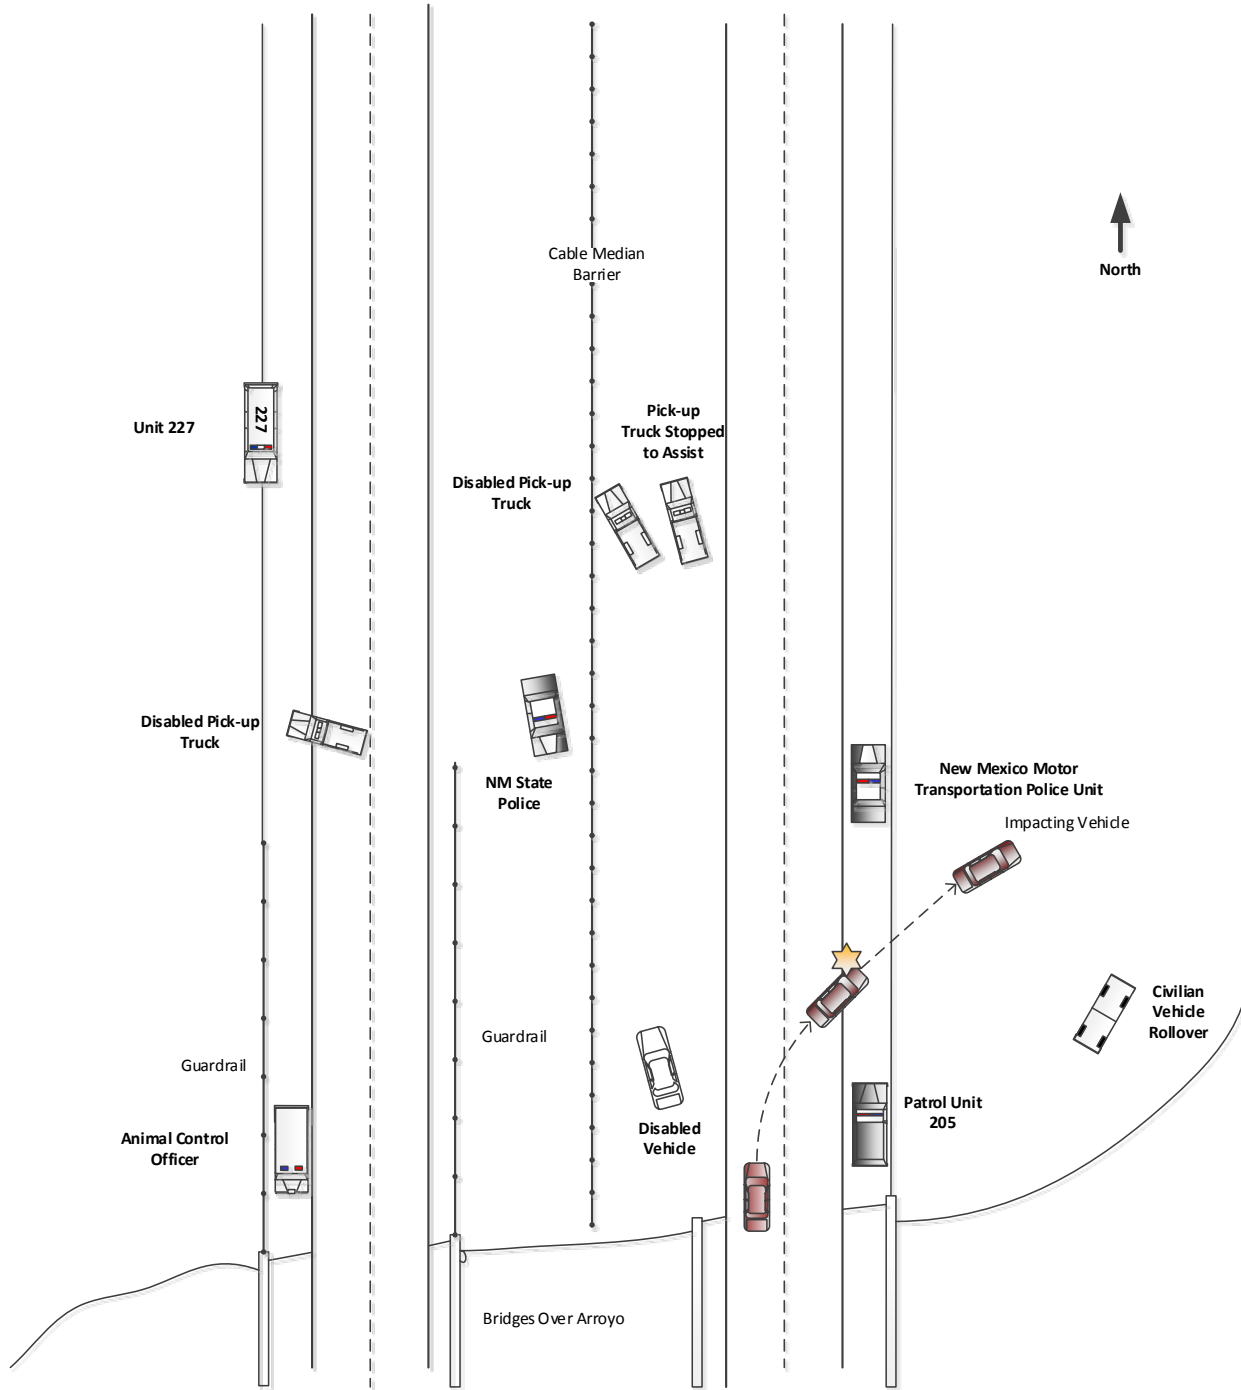
Diagram Not to scale

Diagram Locations of vehicles at the time the sergeant was struck

As shown on the diagram, law enforcement vehicles with lights activated were located along the right hand shoulder of the northbound lanes and a disabled vehicle was located off the left hand shoulder. A law enforcement vehicle with lights activated was also located in the east bound side of the median and disabled vehicles were located on the left hand shoulder, northbound. The location of these vehicles, both left and right of the travel lanes may have made it difficult for the motorist to know which lane to use to provide safe clearance for the responders. Additional traffic control devices such as flares, warning lights or cones located along the right hand shoulder further in advance of the law enforcement vehicles may have prompted the motorist to slow down and move left sooner, allowing him to traverse the area without losing control. Additional emergency vehicles or portable message boards located near the top of the grade may also have served this purpose. Computerized emergency lighting devices are currently available for emergency response and law enforcement vehicles. These lighting devices may be programmed to display lights sequencing left-to-right or right-to-left, warning motorists to move left or right of the emergency vehicles.

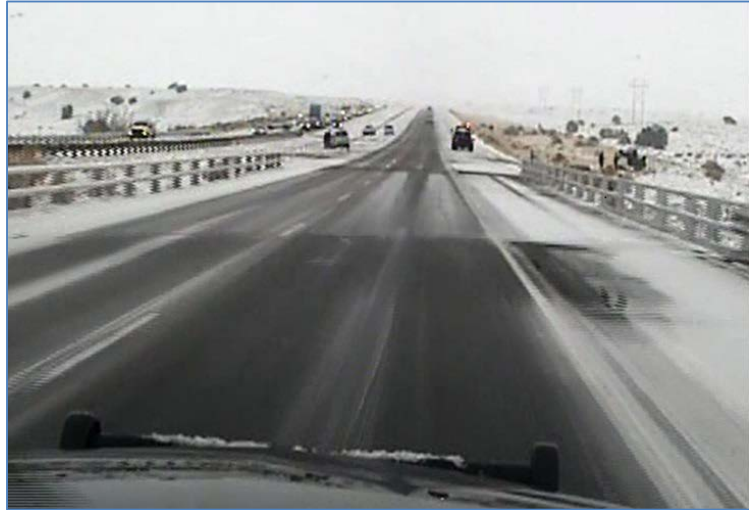
Discussion: During this incident, law enforcement officers responding to the scene were clothed in dark-colored uniforms. Further, as evidenced by the dashcam footage from the MTD unit as it approached the scene northbound, the area near the northbound bridge exit was highly congested (see Image 3). A disabled vehicle was located in the northbound median; a disabled pickup and the pickup of an assisting civilian were also located in the northbound median beyond the first disabled vehicle. To the right was a roll-back tow truck. Note that at the time the striking vehicle was crossing the bridge, the roll-back tow truck had left the scene and the motor transit unit with lights flashing had stopped just short of where the roll-back tow truck had been (see Diagram). Also, as the motorist was crossing the bridge, the sergeant's unit, also with lights flashing, was located on the shoulder near the bridge exit and the sergeant was walking the shoulder toward his vehicle. Finally, the vehicle rollover was located near the edge of the arroyo, off the right shoulder. Three other law enforcement vehicles, all with lights flashing, were located in the southbound median and along the southbound shoulder. The presence of all these vehicles may have distracted the motorist and hampered his ability to see darkly clothed officers on foot in time to safely react to their presence. The use of high-visibility, retro-reflective vests may have permitted the motorist to see the sergeant sooner, allowing more time to react appropriately by

Image 3. Dashcam view of scene prior to incident from northbound MTD unit minutes prior to the incident. Note Number of disable and responding vehicles. (dashcam courtesy of sheriff department)

To meet minimum requirements for high-visibility apparel, responders should only use vests that meet a Class II requirement of ANSI/ISEA 107-2010 (or subsequent revisions) or the requirements of ANSI/ISEA 207-2006 for Public Safety Vests. The minimum requirements include:
